# Manhole Inspection Summary

Manhole # S21EE\_017MH

Insp Date: **6/27/07 9:27 AM**

**Location** Address: **1400 FULTON-MONROE**

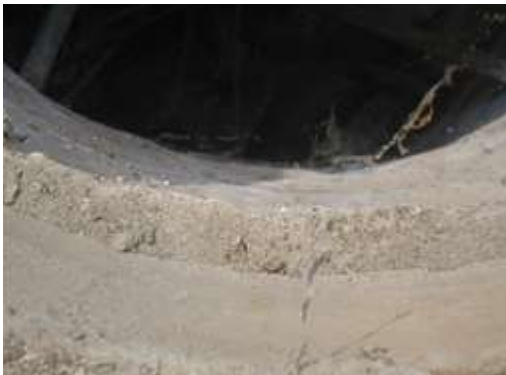
Defect 3

**Frame** Offset: **1** (in.) Condition: ☒ Sound ☐ Cracked ☐ Leaks

FRAME OFFSET

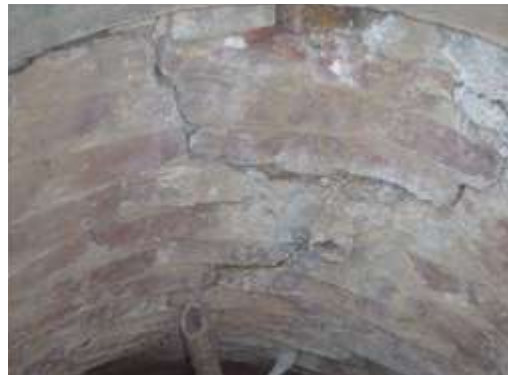
Defect 2

Condition: ☐ Sound ☒ **Cracked** ☐ Root Intrusion ☐ Loose Brick ☐ Deteriorated

CRACKED CORBEL

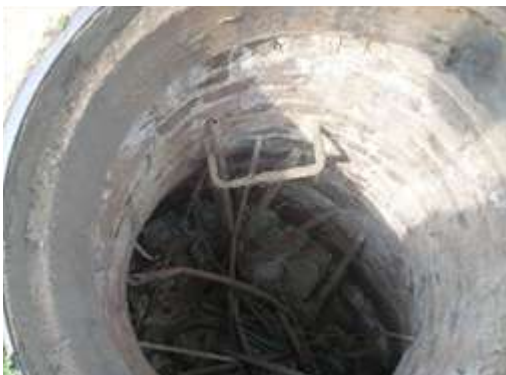
Defect 1

**Steps** Count: **1** Missing: **2** ☒ **Corroded**

1 MISSING STEP/STEP CORRODED

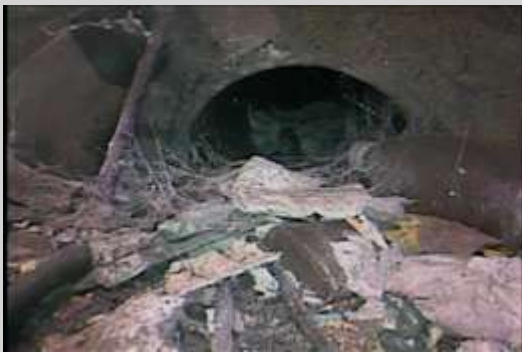
12 O'Clock Outflow

8 in. Circular Gravity Sewer  
Pipe Out @ 12 O'Clock

Deposits: ☐ None ☐ Mud ☐ Sludge ☒ **Debris** ☐ Grease

Silt Depth: **4** (in.) Deposits Extent: **Heavy**
